**Flood Control Project Maintenance  
Levee Inspections**

**Fall 2015 Levee Maintenance Deficiency Summary Report**

**San Joaquin River Basin**

| <b>RD0404</b> | Overall LMA Rating | Total LMA Miles | * Overall LMA Threshold Percent is less than 10.00%; however, U Rated Miles are present, so the Overall LMA Rating is M instead of A. | | | | | |
|--|---|---|---|---|---|---|---|---|
| <b>Reclamation District No. 0404 Boggs</b> | <b>M *</b> | <b>4.10</b> | | | | | | |

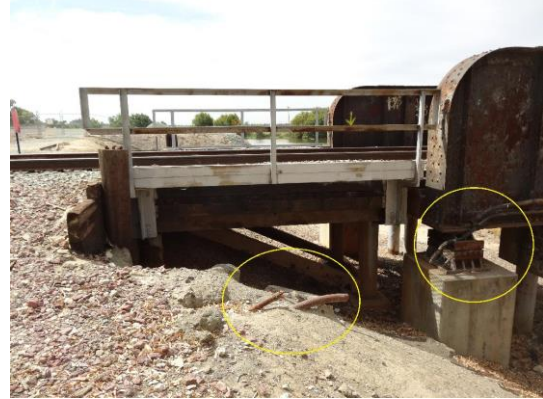
Photo 1 of 3 : UCIP\_FA\_2015\_4408.jpg

WS view looking south: conduits penetrating levee slope now disconnected with those attached to bridge

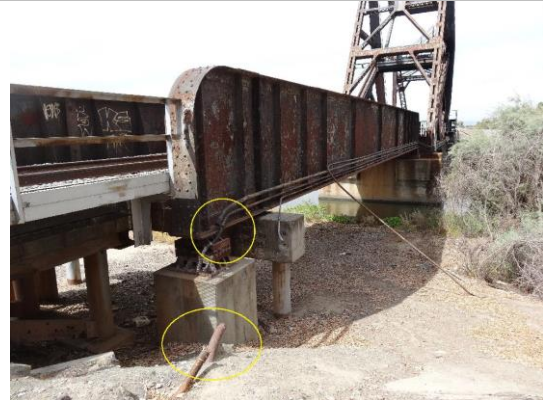
Photo 2 of 3 : UCIP\_FA\_2015\_4411.jpg

WS view looking west: conduits thru levee and attached to bridge

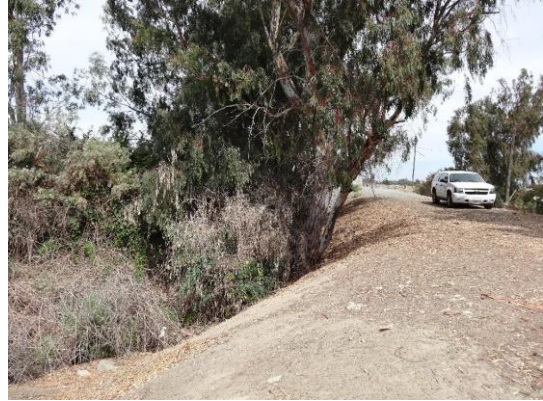
Photo 3 of 3 : UCIP\_FA\_2015\_4412.jpg

WS view at crossing looking north

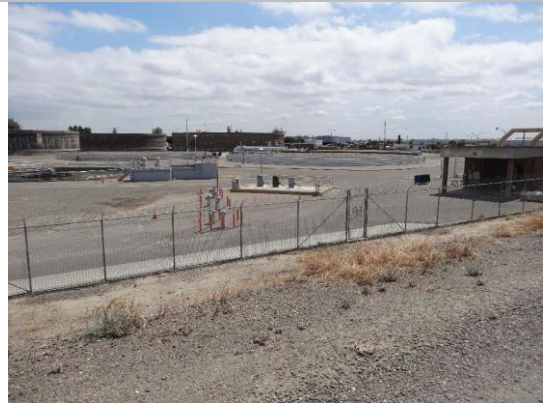
Photo 1 of 2 : UCIP\_FA\_2015\_4407.jpg

LS view: apparent shut off valves on WWTP property in alignment with 60-inch pipe.

Inspector Comments: FS\_ID:46801  
 DS\_ID:25128  
 EP\_NO: 1164  
 FS\_HLM: 1.09  
 Repair Type: Non-Urgent  
 Crossing Status: Indicator Found  
 UCIP Comments: Conversation with WWTP engineer Ali Gharegozloo suggested this pipe has been welded shut. If so, mode of abandonment needs verification.  
 FIELD\_STRUCT\_DESC: 60-inch reinforced concrete sewage pipe 27 FBC. Reinforced concrete apron and cut-off walls, steel sheet piling apron installed with pipe on WS slope. Headwall, stairs, pump with shutoff valve visible on WS slope. Apparent shut off valves 30 ft off LS toe in alignment with pipe. Permit No. 1164, 1947.  
 FS Date: 07/09/2015

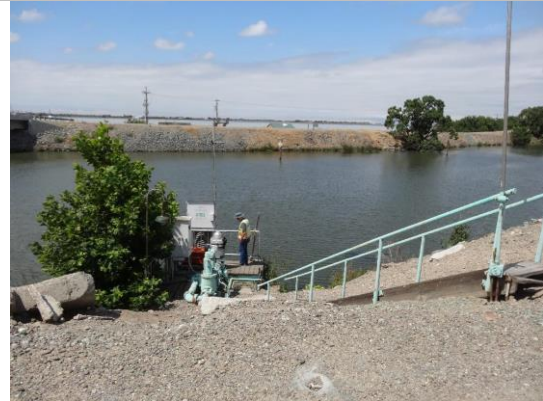
Photo 2 of 2 : UCIP\_FA\_2015\_4409.jpg

WS view: pump with shutoff valves, headwall, stairs visible. Concrete debris along WS slope.

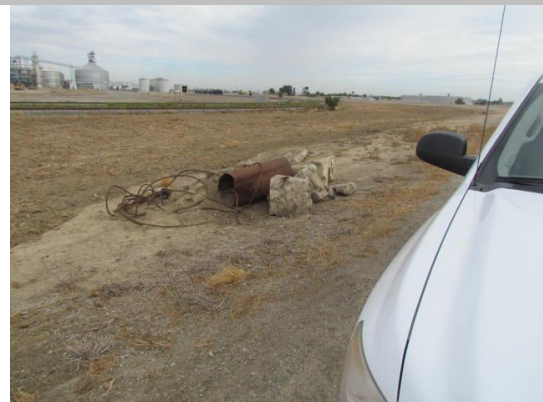
Photo 1 of 1 : FA\_2015\_RD0404\_305\_31\_20151019\_00029.jpg

Looking southeast at concrete blocks on landward slope.

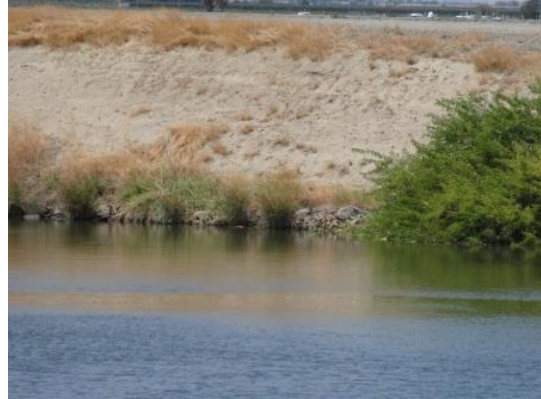
Photo 1 of 2 : SJR2015\_RD0404U01RM41.11\_3.jpg

| Inspector Comments: 06/24/2015: No significant change observed.<br>6/19/2014: No significant change observed.<br>08/13/2013: No significant change at this site.<br>8/7/2012: The erosion is next to a repaired site and approximately 400 feet downstream of a river bend. There are broken concretes at the upper levee slope, but not visible at the levee toe or lower slope. Likely | | | | | |

Close view of the site.

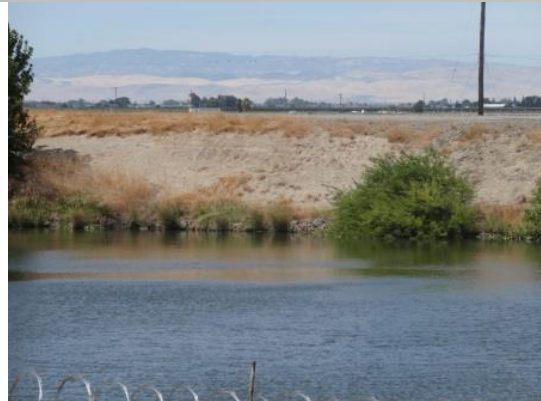
Photo 2 of 2 : SJR2015\_RD0404U01RM41.11\_5.jpg

A closer view of the site.

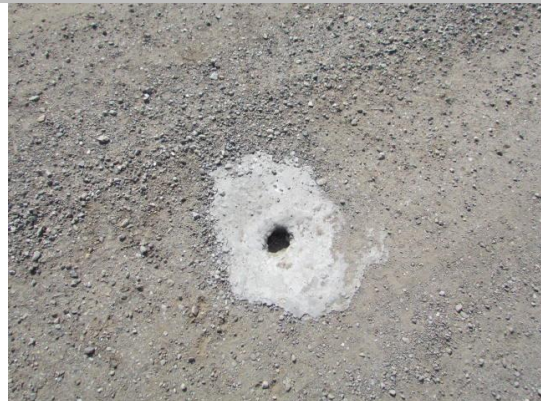
Photo 1 of 4 : FA\_2015\_RD0404\_305\_5\_20150914\_00004.jpg

| No rodents visible, but rodent burrows visible; need to backfill and compact or grout burrows.<br>Inspector Comments: District grouted hole, and the deficiency still exist. | | | | | |

Looking at partialled grouted rodent hole on levee crown (Fall 2014).

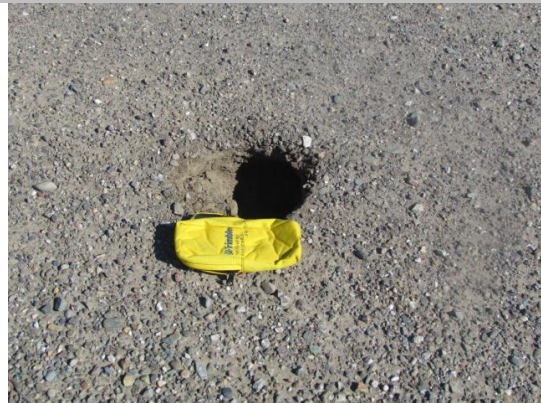
Photo 3 of 4 : FA\_2015\_RD0404\_305\_5\_20150914\_00006.jpg

Looking at rodent hole on levee crown.

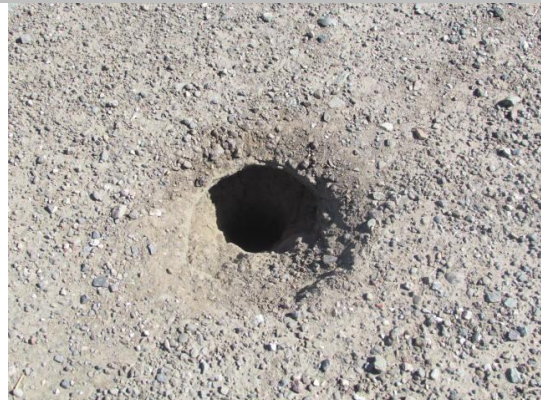
Photo 4 of 4 : FA\_2015\_RD0404\_305\_5\_20150914\_00007.jpg

Looking at one of several rodent holes on levee crown.

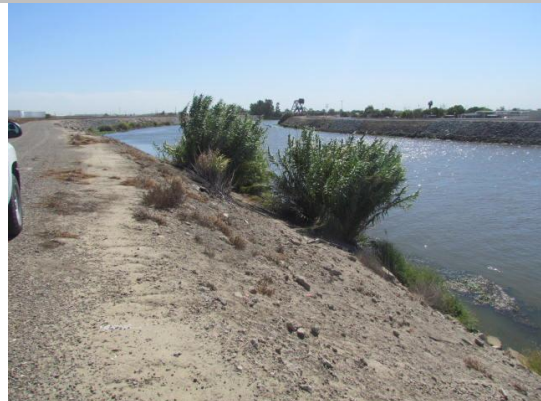
Photo 2 of 3 : FA\_2015\_RD0404\_305\_104\_20150914\_00023.jpg

Looking west at bamboo on waterward slope. 2013

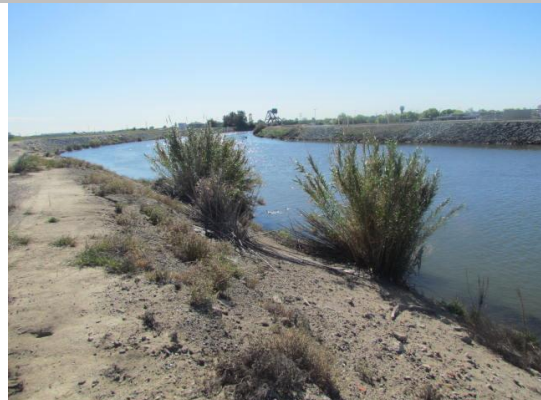
Photo 3 of 3 : FA\_2015\_RD0404\_305\_104\_20150914\_00024.jpg

Looking southwest at bamboo on waterward slope and toe.

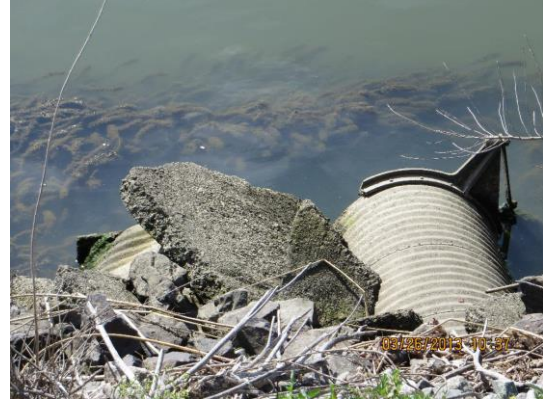
Photo 1 of 3 : UCIP\_FA\_2015\_0870.jpg

WS- closer view of right CM pipe with damaged flap gate

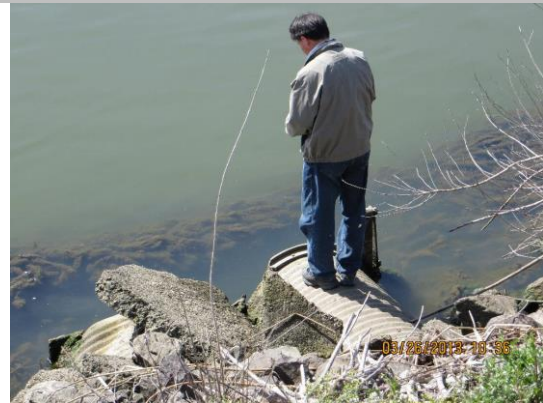
Photo 2 of 3 : UCIP\_FA\_2015\_0871.jpg

WS- right CM pipe with damaged flap gate

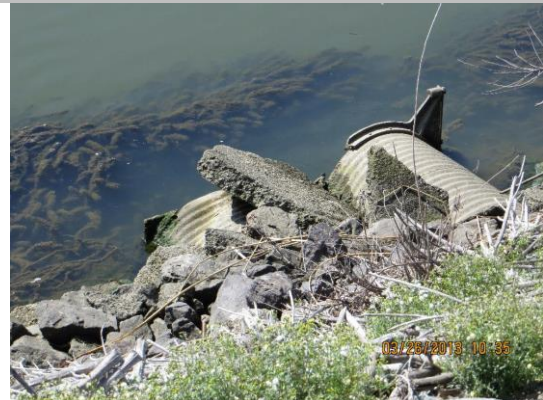
Photo 3 of 3 : UCIP\_FA\_2015\_0872.jpg

WS- two CM pipes with damaged flap gates

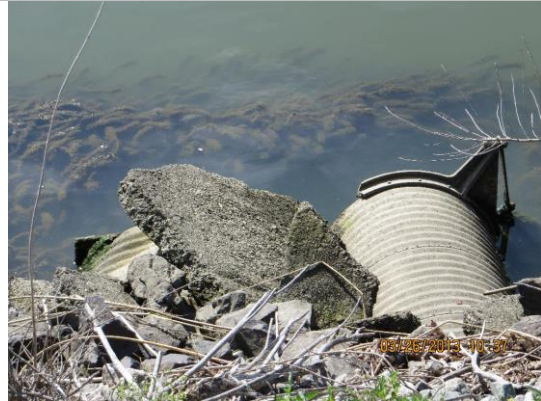
Photo 1 of 3 : UCIP\_FA\_2015\_0867.jpg

WS- closer look at left CM pipe with missing flap gate

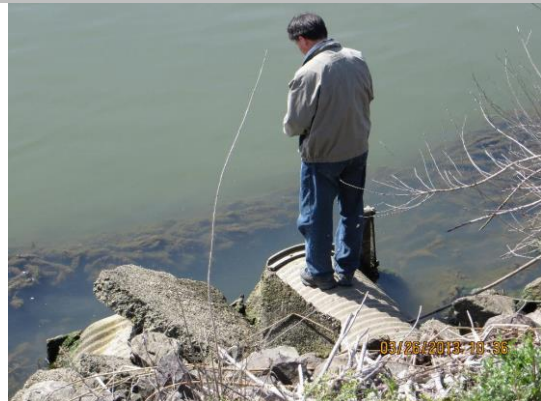
Photo 2 of 3 : UCIP\_FA\_2015\_0868.jpg

WS- left CM pipe with missing flap gate

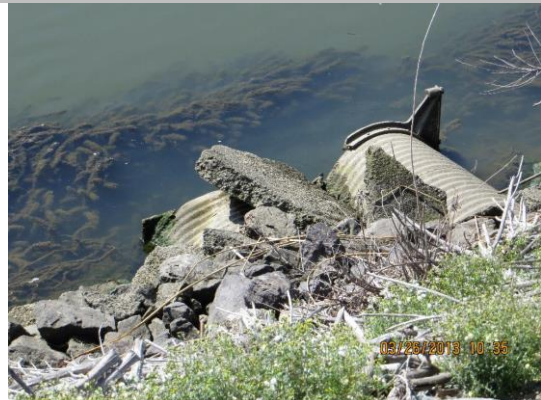
Photo 3 of 3 : UCIP\_FA\_2015\_0869.jpg

WS- two CM pipes with damaged flap gates

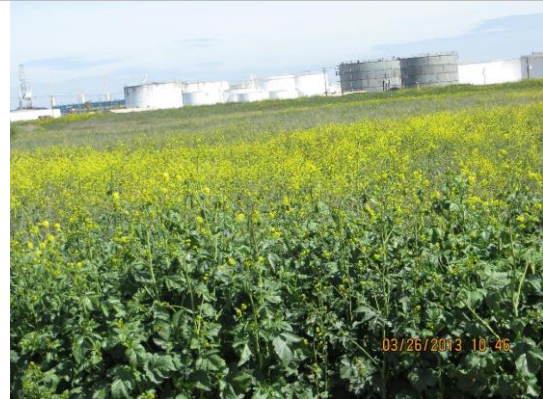
Photo 1 of 2 : UCIP\_FA\_2015\_0422.jpg

LS- overview of land side of the levee.

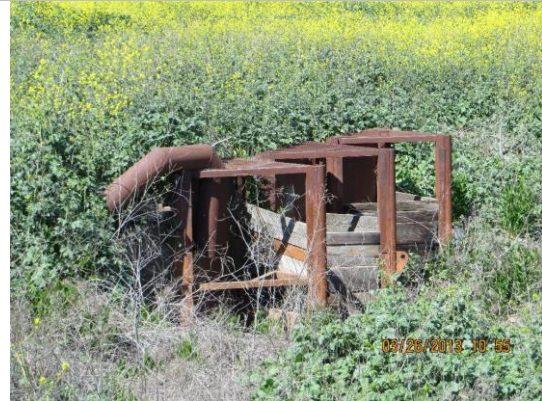
Photo 2 of 2 : UCIP\_FA\_2015\_0887.jpg

Inspector Comments: FS\_ID:11087  
DS\_ID:17952  
EP\_NO: N/A  
FS\_HLM: 0.6624  
Repair Type: Non-Urgent  
Crossing Status: Found  
UCIP Comments: Steel intake structure on landside of the levee.  
FIELD\_STRUCT\_DESC: 2 of 3. 30-inch pipes through levee, 22.0 feet below the crown. Waterward end with flap gates. Landward end filled with dirt. Steel intake structure on landside of the levee. Middle flap gate missing and right flap gate broken as of 1/24/07.  
FS Date: 03/26/2013

LS- intake structure

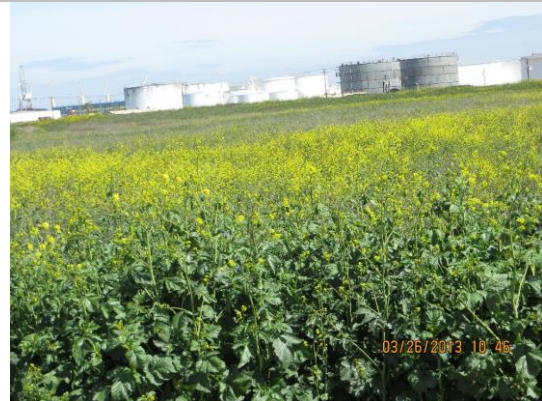
Photo 1 of 3 : UCIP\_FA\_2015\_0893.jpg

Inspector Comments: FS\_ID:12384  
DS\_ID:18810  
EP\_NO: N/A  
FS\_HLM: 0.662  
Repair Type: Non-Urgent  
Crossing Status: Found  
UCIP Comments: Steel intake structure on LS.  
FIELD\_STRUCT\_DESC: 1 of 3. 30-inch CM pipes through levee, 22.0 feet below the crown. Waterward end with damaged flap gates. Steel intake structure on landside. On waterside, middle flap gate missing and right flap gate broken as of 1/24/07.  
FS Date: 03/26/2013

LS- overview of landside of the levee.

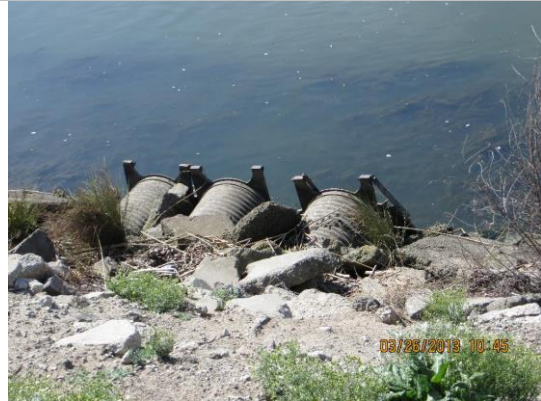
Photo 2 of 3 : UCIP\_FA\_2015\_0894.jpg

| FIELD_STRUCT_DESC: 1 of 3. 30-inch CM pipes through levee, 22.0 feet below the crown. Waterward end with damaged flap gates. Steel intake structure on landside. On waterside, middle flap gate missing and right flap gate broken as of 1/24/07. | | | | | | |

WS- CM pipes with damaged flap gates

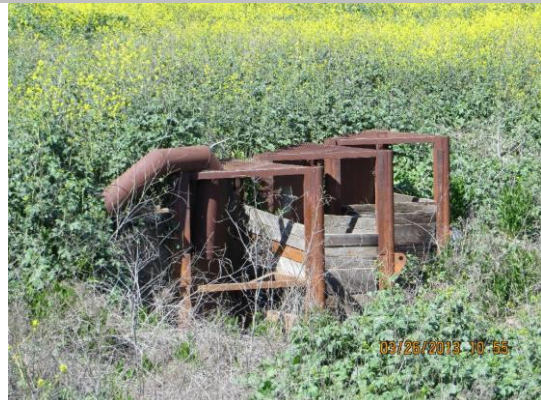
Photo 3 of 3 : UCIP\_FA\_2015\_0895.jpg

LS- steel intake structure

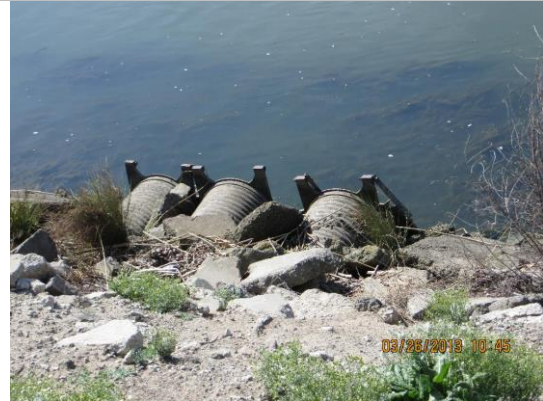
Photo 1 of 2 : UCIP\_FA\_2015\_0888.jpg

WS- CM pipes and damaged flap gates

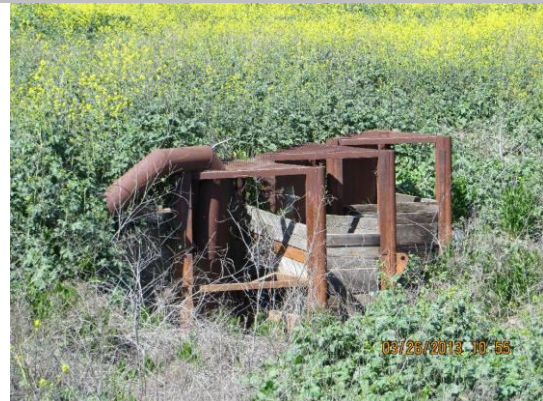
Photo 2 of 2 : UCIP\_FA\_2015\_0889.jpg

LS- steel intake structure

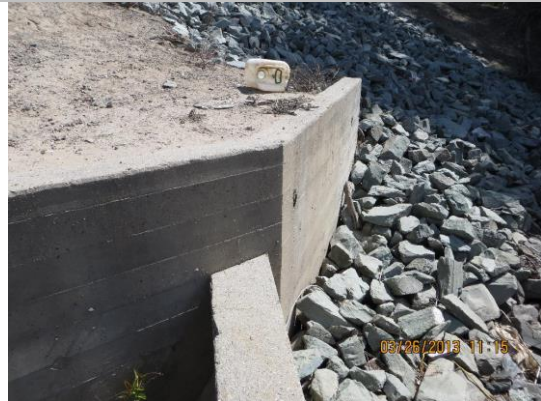
Photo 1 of 3 : UCIP\_FA\_2015\_0842.jpg

WS- slightly tilted outlet structure

Inspector Comments: FS\_ID:46628  
 DS\_ID:17945  
 EP\_NO: N/A  
 FS\_HLM: 0.76  
 Repair Type: Urgent  
 Crossing Status: Found  
 UCIP Comments: Partially buried flap gate  
 FIELD\_STRUCT\_DESC: 42-inch CM drainage pipe 18.0 FBC. Flap gate, concrete headwall and spillway on WS. Pump house on LS.  
 Abandoned concrete headwall, power pole, and 2 wooden piles found on LS. O&M #: SJR 001  
 FS Date: 08/04/2015

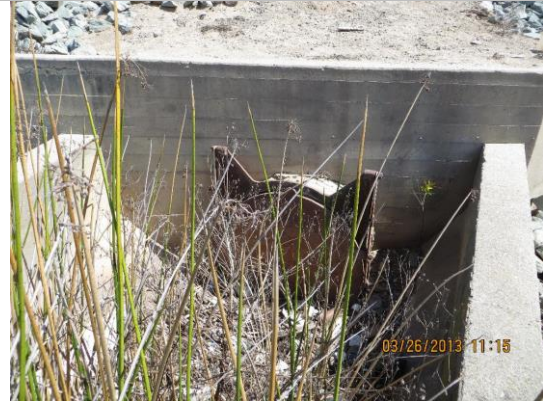
Photo 2 of 3 : UCIP\_FA\_2015\_0843.jpg

WS- Debris and vegetation blocking CM drainage pipe

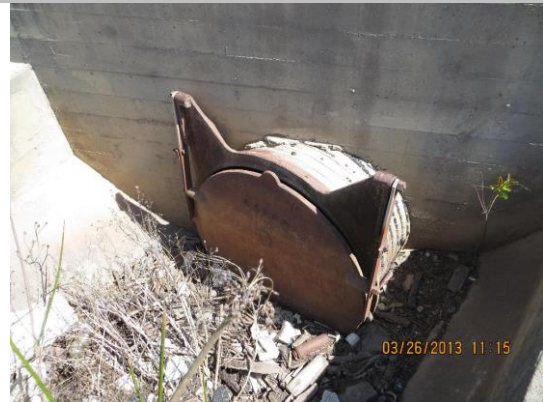
Photo 3 of 3 : UCIP\_FA\_2015\_0844.jpg

WS- drainage outlet structure and CM pipe with flapgate

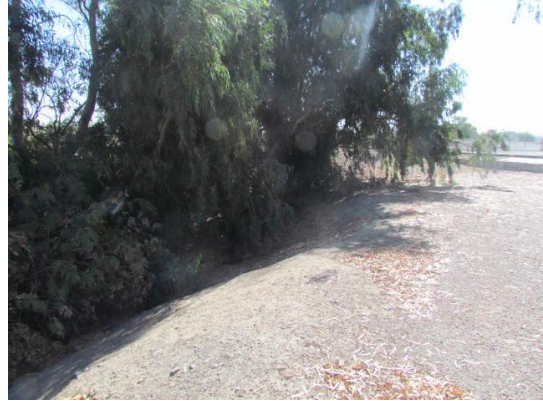
Photo 1 of 1 : FA\_2015\_RD0404\_305\_8\_20150914\_00009.jpg

Looking southeast at dense trees on landward slope and toe.

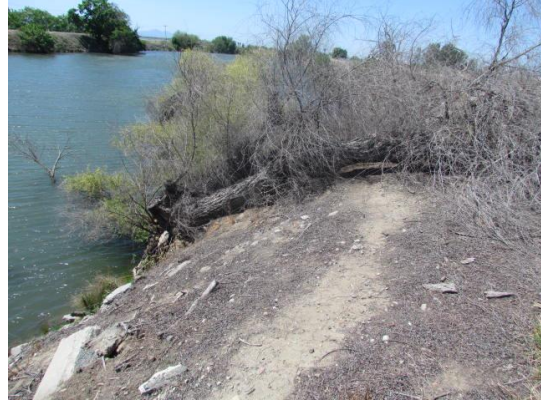
Photo 1 of 2 : FA\_2015\_RD0404\_305\_3\_20150914\_00001.jpg

Looking northwest at downed tree on waterward slope and shoulder.

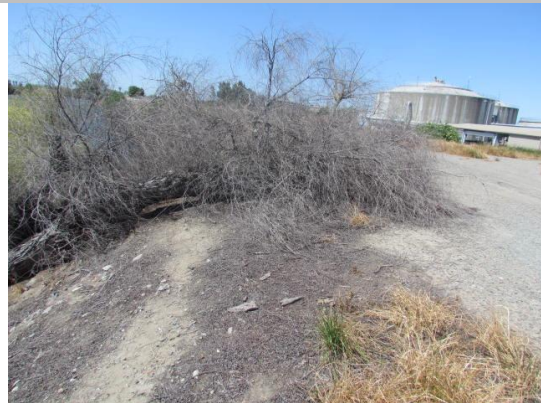
Photo 2 of 2 : FA\_2015\_RD0404\_305\_3\_20150914\_00002.jpg

Looking north at downed tree on waterward slope and shoulder.

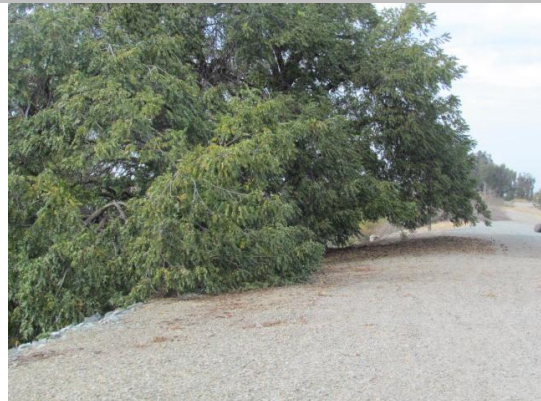
Photo 1 of 1 : FA\_2015\_RD0404\_305\_102\_20151019\_00031.jpg

Looking northwest at untrimmed tree on waterward slope.

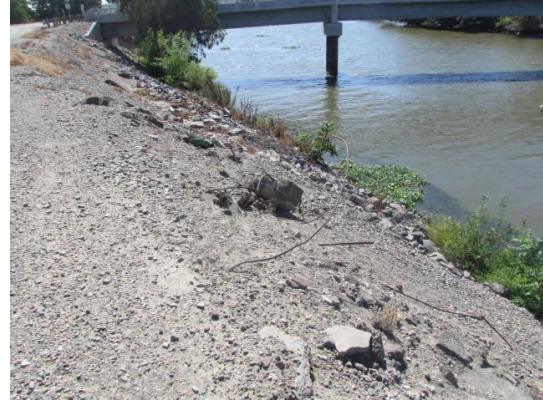
Photo 1 of 1 : FA\_2015\_RD0404\_305\_4\_20150914\_00003.jpg

Looking southwest at concrete rubble with rebar on waterward slope.

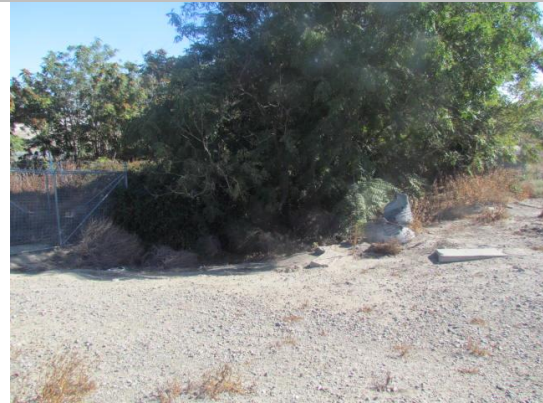
Photo 1 of 1 : FA\_2015\_RD0404\_305\_101\_20150914\_00021.jpg

Looking southeast at overhanging trees on landside slope.

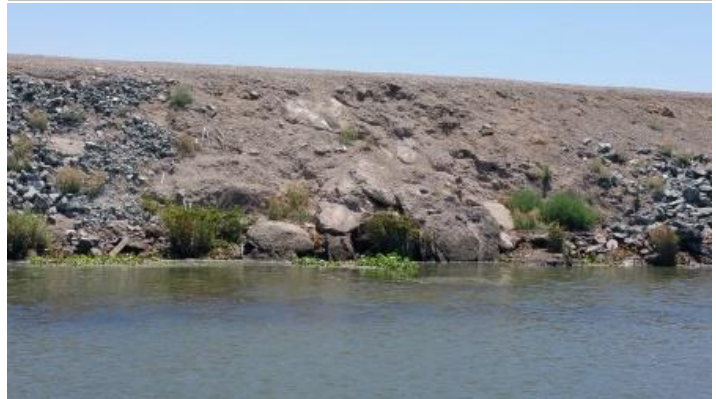
Photo 1 of 2 : SJR2015\_RD0404U01RM42.02\_1.JPG

| Inspector Comments: 06/24/2015: No significant change observed.<br>06/19/2014: A series of scarp erosions have been found on the lower levee slope and at the levee toe. [2015 Site ID:RD0404U01RM42.02] | | | | | |

Front view of the erosion.

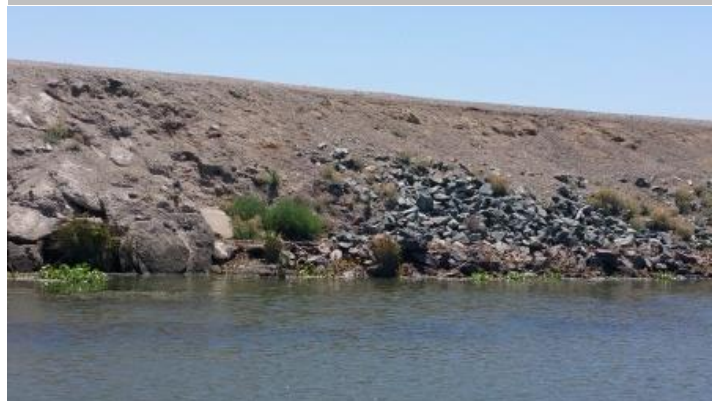
Photo 2 of 2 : SJR2015\_RD0404U01RM42.02\_3.JPG

Close view of the erosion. The upstream end of the site is protected by riprap revetment.

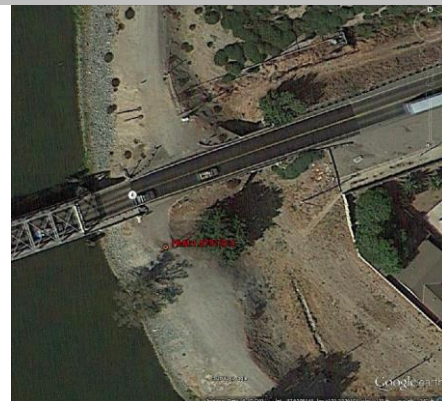
Photo 1 of 1 : UCIP\_FA\_2015\_0896.jpg

Aerial Photo @HLM=1.5791: No sign posts/markers found.

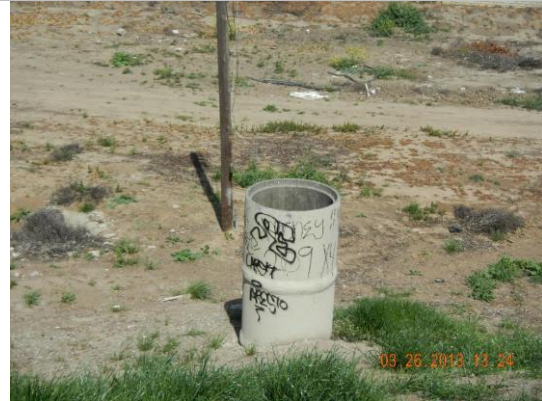
Photo 1 of 3 : UCIP\_FA\_2015\_0897.jpg

| Inspector Comments: FS_ID:40487<br>DS_ID:18812<br>EP_NO: 10897<br>FS_HLM: 1.65<br>Repair Type: Non-Urgent<br>Crossing Status: Found<br>UCIP Comments: Abandoned crossing. WS pipe capped with steel pipe and LS pipe cut.<br>FIELD_STRUCT_DESC: Abandoned 14-inch irrigation pipe. 3.0 feet below levee crown (Permit No. 10897).<br>FS Date: 03/26/2013 | | | | | |

LS- concrete standpipe on levee slope

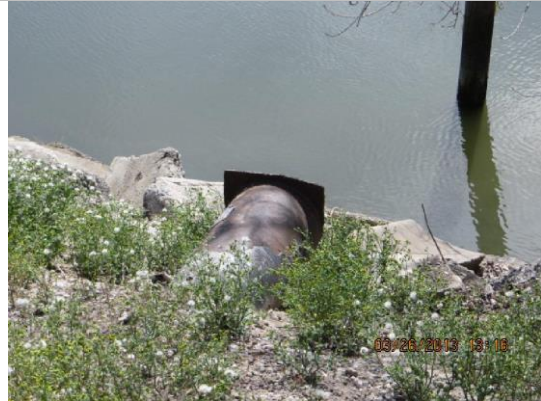
Photo 3 of 3 : UCIP\_FA\_2015\_0899.jpg

WS- abandoned steel pipe capped with steel plate.

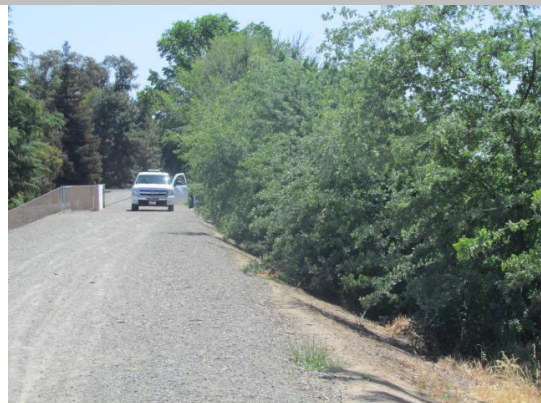
Photo 1 of 1 : FA\_2015\_RD0404\_305\_29\_20150914\_00018.jpg

Looking east at untrimmed trees on waterward slope.

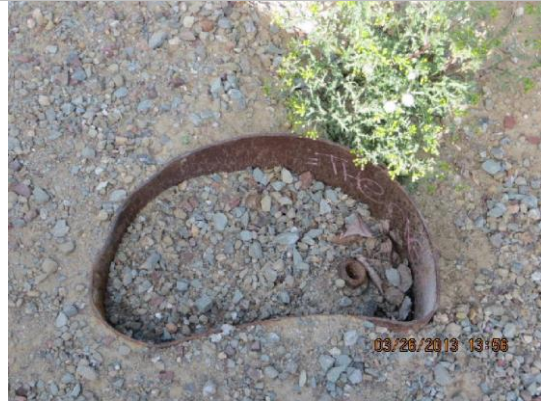
Photo 1 of 3 : UCIP\_FA\_2015\_0519.jpg

| Action/Comments | | | | | |
|--|--|--|--|--|--|
| Inspector Comments: FS_ID:40797<br>DS_ID:17961<br>EP_NO: 6560<br>FS_HLM: 1.814<br>Repair Type: Non-Urgent<br>Crossing Status: Found<br>UCIP Comments: Damaged siphon breaker in pipe riser near the landward shoulder.<br>FIELD_STRUCT_DESC: 8-inch pipe through the levee, 7.0 feet below the crown, chain link fence around pump and motor on the waterward slope. (Permit. No. 6560)<br>FS Date: 03/26/2013 | | | | | |

LS- damaged and obstructed siphon breaker on levee shoulder.

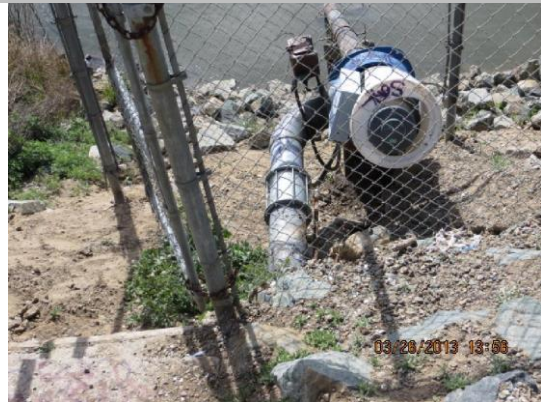
Photo 2 of 3 : UCIP\_FA\_2015\_0520.jpg

WS- slanted pump, and pipe on levee slope.

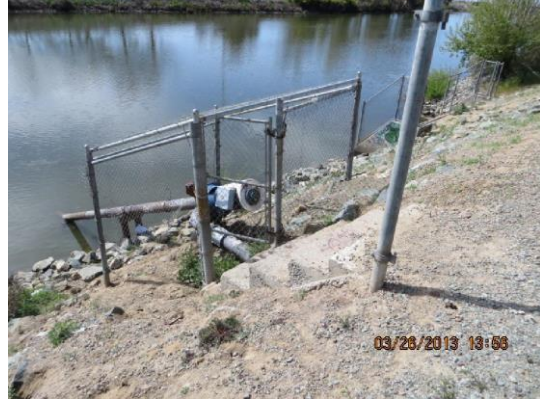
Photo 3 of 3 : UCIP\_FA\_2015\_0620.jpg

WS- slanted pump, pipe, and concrete steps on levee slope.

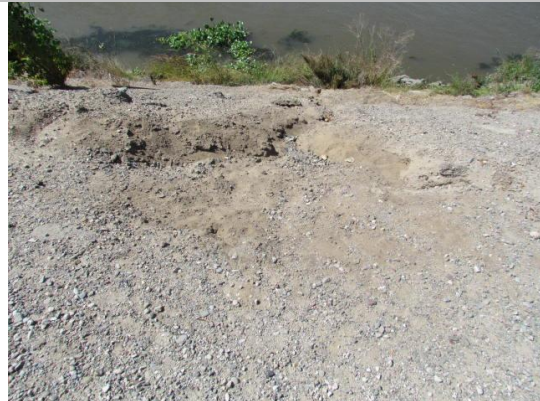
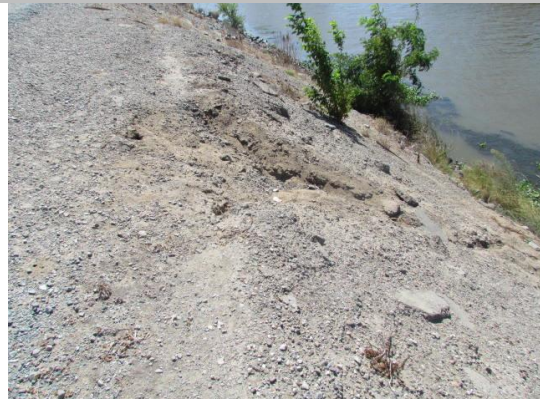
| Inspector Comments: Slope damage due to foot traffic. | | | | | |

Looking west at slope damage due to foot traffic.

Looking southwest at slope damage due to foot traffic.

| Repair the levee slope damaged by foot traffic and prevent access where possible. | | | | | |

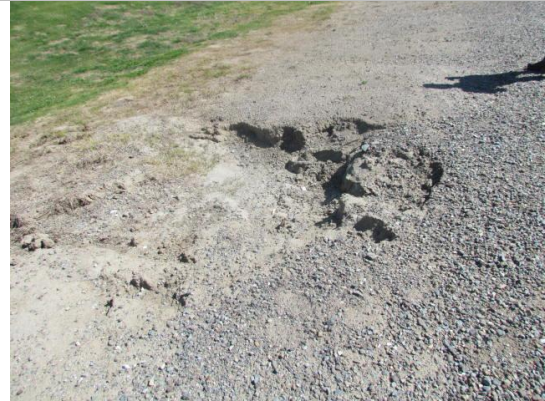
Photo 1 of 2 : FA\_2015\_RD0404\_305\_28\_20150914\_00016.jpg

Looking east at erosion on landward slope.

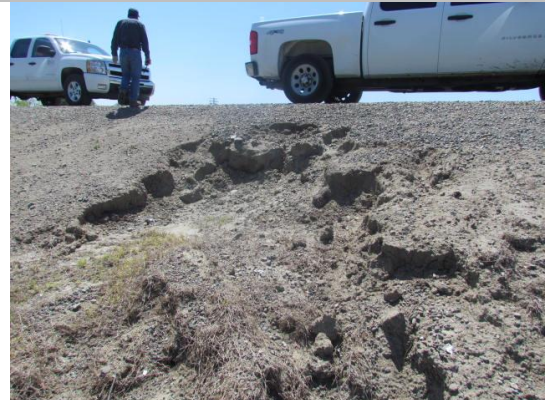
Photo 2 of 2 : FA\_2015\_RD0404\_305\_28\_20150914\_00017.jpg

Looking west at erosion on landward slope.

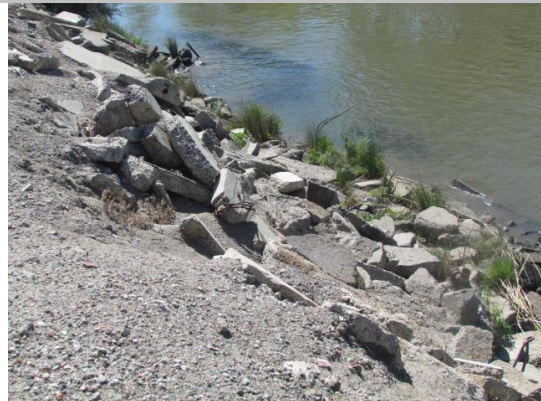
Photo 2 of 2 : FA\_2015\_RD0404\_305\_23\_20150914\_00015.jpg

Looking southwest at concrete rip rap with rebar.

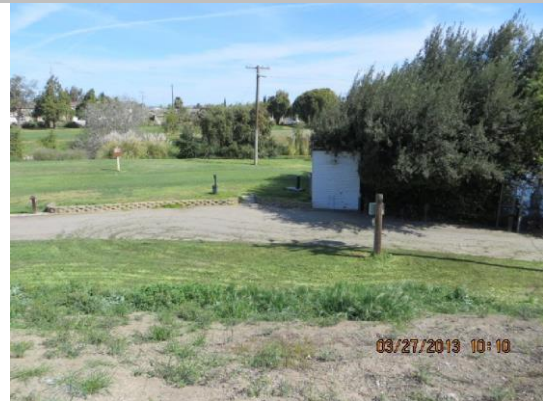
Photo 1 of 3 : UCIP\_FA\_2015\_0371.jpg

LS- overview of LS slope

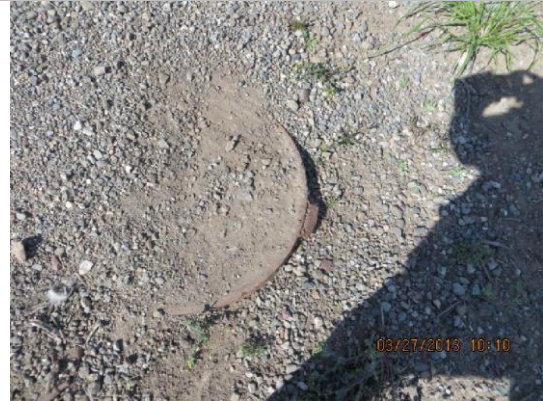
Photo 2 of 3 : UCIP\_FA\_2015\_0372.jpg

WS- damaged, obstructed and buried siphon breaker

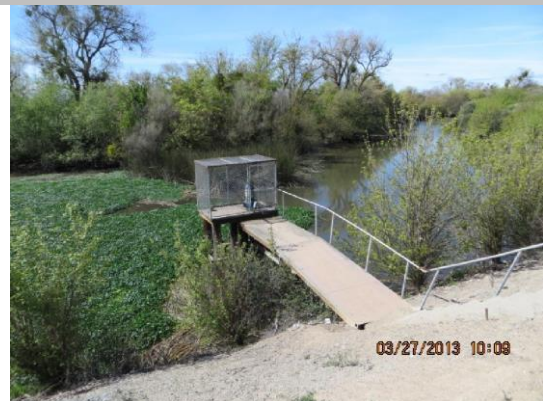
Photo 3 of 3 : UCIP\_FA\_2015\_0373.jpg

WS- pump on steel structure and wooden walkway

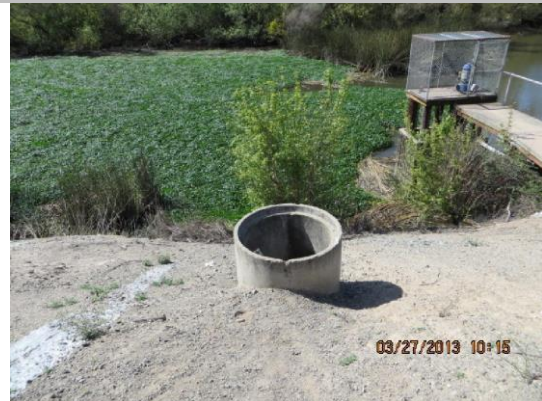
Photo 1 of 2 : UCIP\_FA\_2015\_0443.jpg

WS- concrete riser on steep levee slope

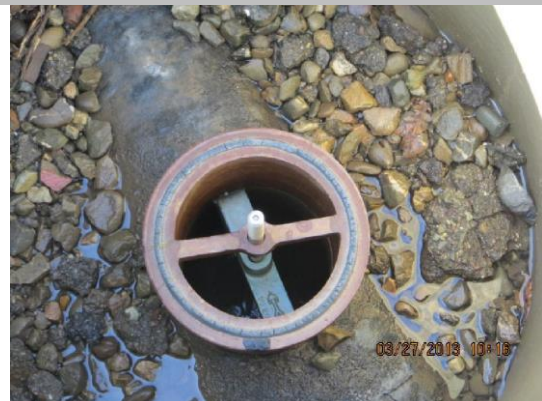
Photo 2 of 2 : UCIP\_FA\_2015\_0444.jpg

WS- siphon breaker without cap in concrete riser

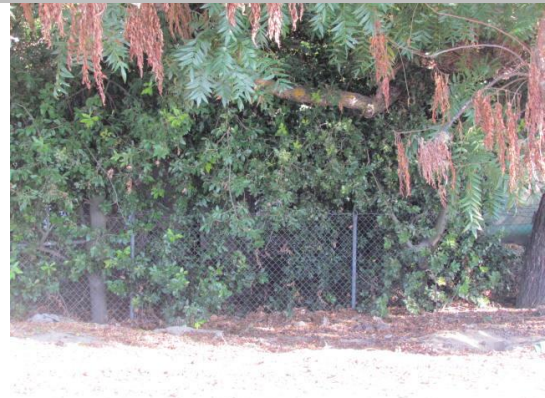
Photo 1 of 4 : FA\_2015\_RD0404\_306\_67\_20150914\_00007.jpg

Looking northeast at dense vegetation inside fenced area near pump station on landside toe.

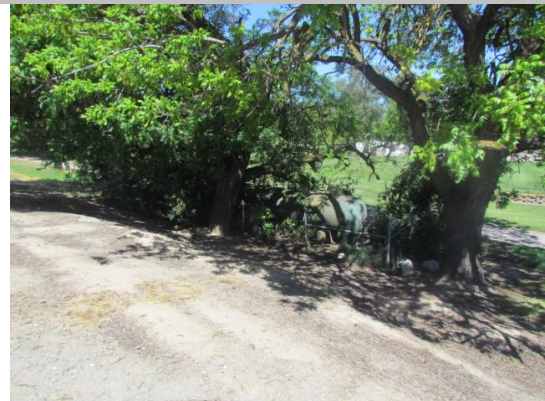
Photo 2 of 4 : FA\_2015\_RD0404\_306\_67\_20150914\_00008.jpg

Looking north at dense vegetation on landward toe around propane tank.

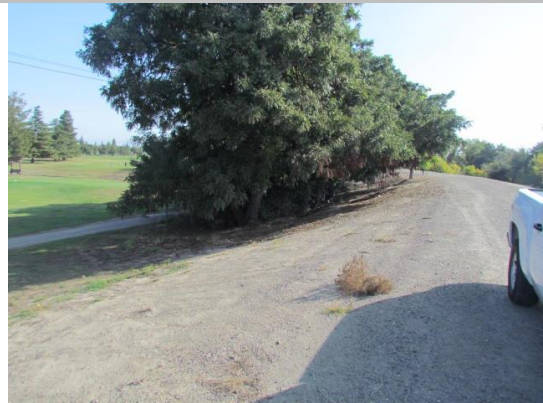
Photo 4 of 4 : FA\_2015\_RD0404\_306\_67\_20150914\_00010.jpg

Looking east at dense vegetation near pump station on landside toe.

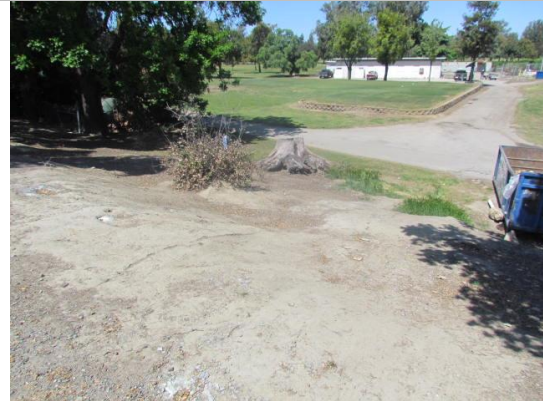
Photo 1 of 1 : FA\_2015\_RD0404\_306\_15\_20150914\_00005.jpg

Looking east at dead stump on landward toe.

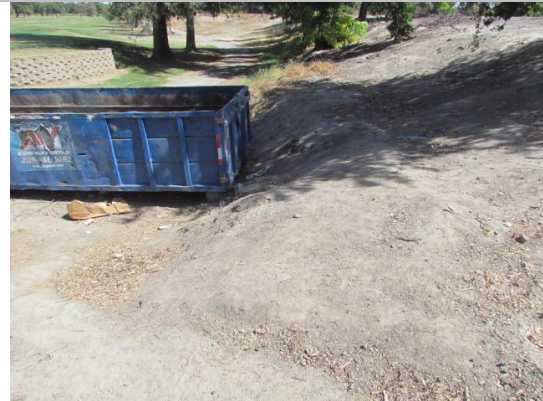
Photo 1 of 1 : FA\_2015\_RD0404\_306\_13\_20150914\_00004.jpg

Looking southeast at dumpster and landside erosion on landward toe.

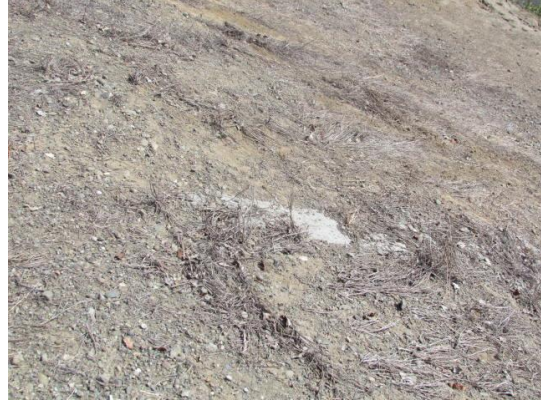
Photo 1 of 1 : FA\_2015\_RD0404\_306\_10\_20150914\_00003.jpg

Looking southeast at typical grouted rodent holes on landward slope.

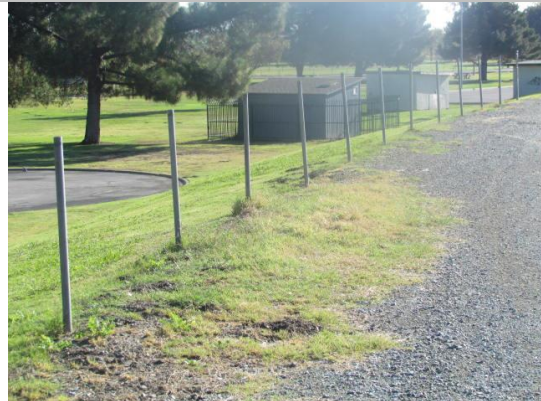
Photo 1 of 2 : FA\_2015\_RD0404\_306\_6\_20150914\_00001.jpg

Looking northeast at fence poles on landside shoulder.

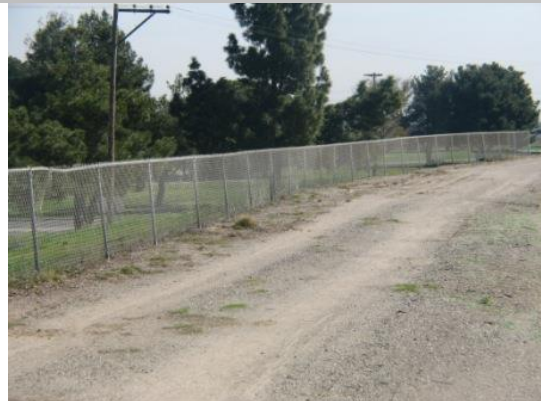
Photo 2 of 2 : FA\_2015\_RD0404\_306\_6\_20150914\_00002.jpg

Fence at landside shoulder from LM 1.47 to 1.52

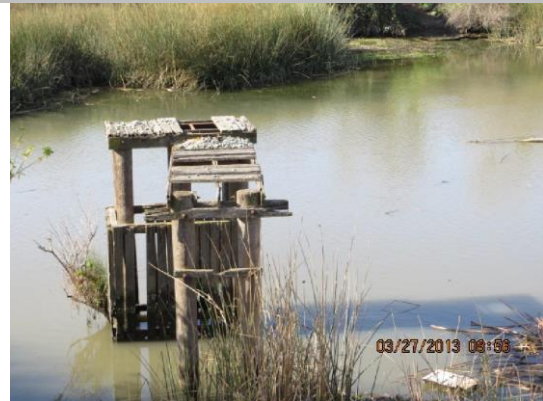
Photo 1 of 3 : UCIP\_FA\_2015\_0330.jpg

WS- abandoned pump station.

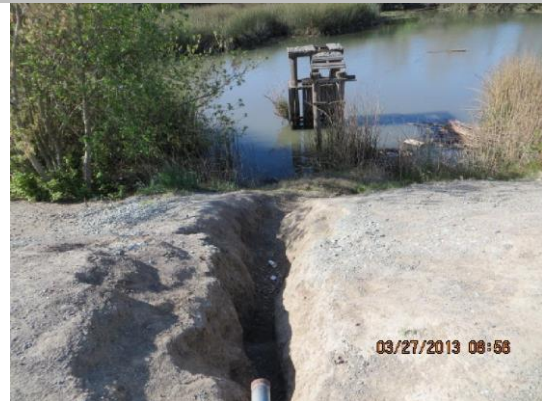
Photo 2 of 3 : UCIP\_FA\_2015\_0331.jpg

WS- soil erosion and gully formation due to leaky pipe

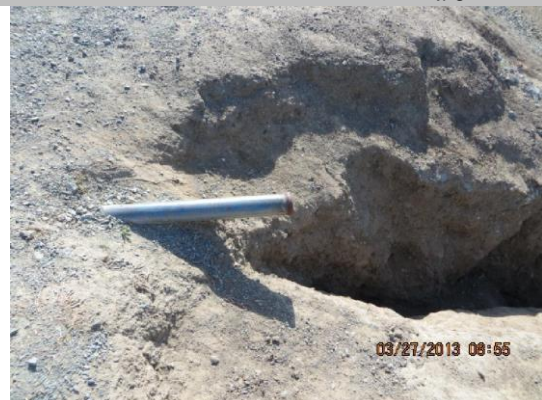
Photo 3 of 3 : UCIP\_FA\_2015\_0332.jpg

WS- capped 3-inch GI pipe

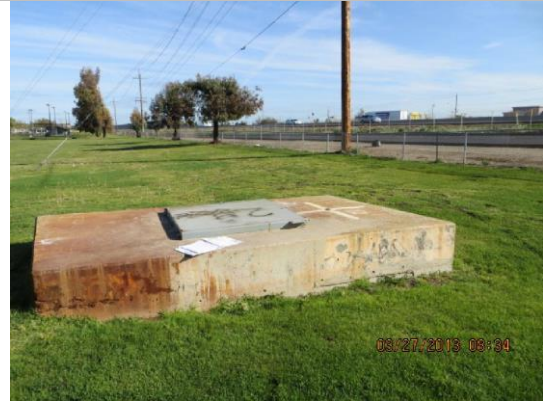
Photo 2 of 2 : UCIP\_FA\_2015\_0650.jpg

LS- 7' x 14' concrete vault.

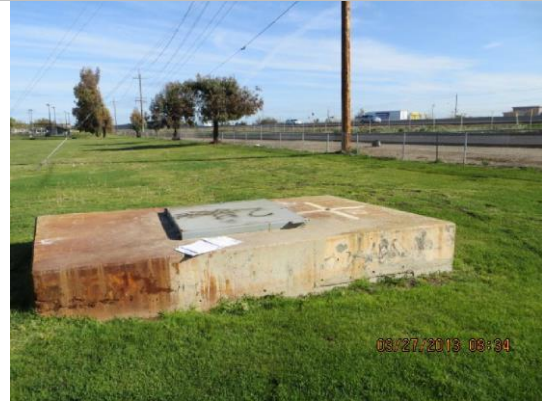
Photo 2 of 2 : UCIP\_FA\_2015\_0329.jpg

LS- 7' x 14' concrete vault.
